Health & Safety Risk Assessment – Amenities Only.

Address of premises:	Heronbridge Close Westlea Swindon SN5 7DR
Responsible Person:	Heronbridge Close Freehold Company Ltd
Duty Holder:	Block Management Ltd
Person(s) consulted:	No occupier or other relevant person available to consult.
Assessor:	Josh Godfrey, TIFireE.
Report validated by:	John Godfrey, GIfireE.
Date of fire risk assessment:	11 th September 2024/ Reviewed September 2025
Date of previous fire risk assessment:	Not known
Suggested date for review:	September 2026

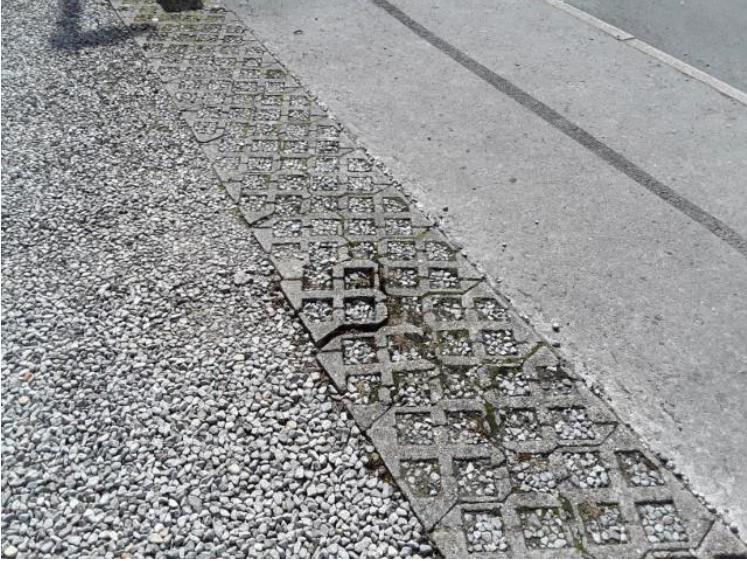
ACTION PLAN				
Action	Detail (to be read in conjunction with the report findings)	Priority	Action by whom	Date action undertaken
01	<p>It was noted during this assessment that there is a loose floor slab to the carpark of units 7, 8, 9. It is recommended that this slab be repaired or replaced in order to reduce the risk of a trip occurring.</p>

MED	Client	<p>Ongoing Action required</p> <p>Contractor has made adjustment to slabs across the site. To be monitored.</p>
02	<p>It was noted during this assessment that the drain outside unit 13 presents a significant trip hazard. It is recommended that this drain be repaired in order to drastically reduce the risk of a trip occurring.</p>

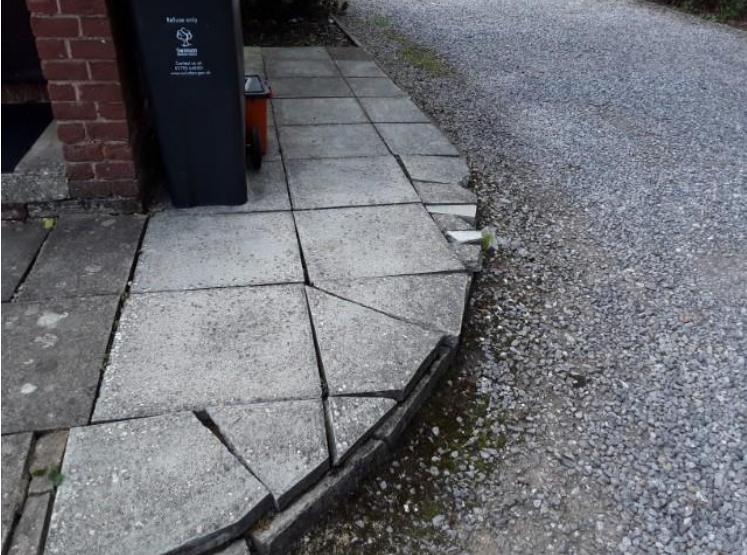
03	<p>It was noted during this assessment that there are numerous loose and damaged floor tiles outside unit 16. It is recommended that these tiles be repaired or replaced in order to reduce the risk of a trip occurring.</p>

MED	Client	<p>Ongoing Action required As above</p>
04	<p>It was noted during this assessment that there are numerous uneven floor tiles outside unit 18. It is recommended that these tiles be repaired in order to reduce the risk of a trip occurring.</p>
